## **TEST AND EVALUATION STATUS REPORT 1 Updated**

*Characterization of Prototype Asphalt Shingle Rejuvenator, Invigosoy Roof ISR 0003*

**Project No.:** ISU 01-02-01

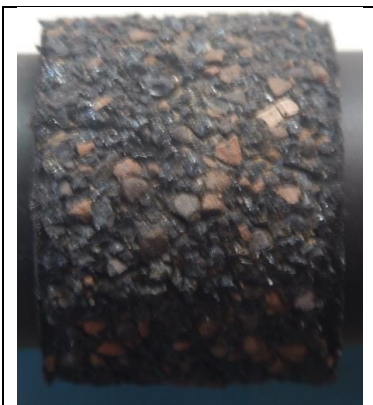
Control @ 110°F (Fail)

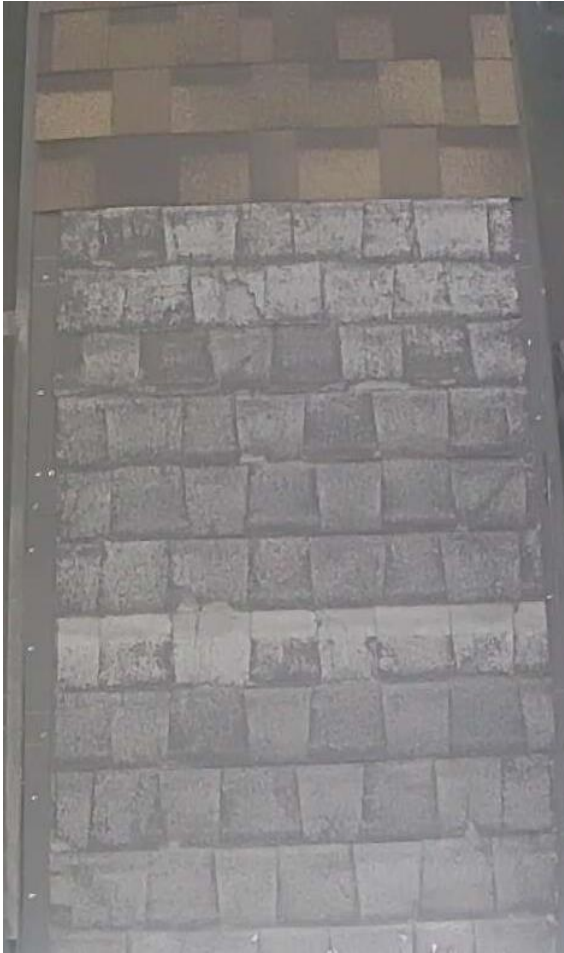
### Deck C – Spread of Flame Test

Spread of Flame Test – Deck C applied at 200 ft<sup>2</sup>/gal (13.5 ft<sup>2</sup>, 8.64 oz. applied)

Deck C burned 29" passes a Class A, burned 15" less than control

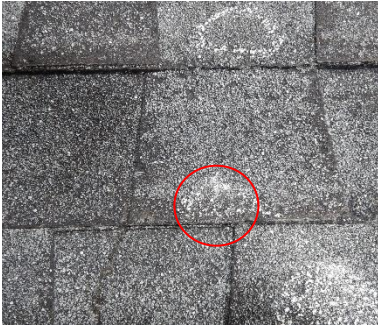
#### Control Deck

Fail -  
Cracking

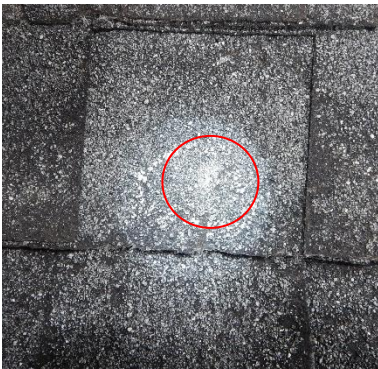
Fail -  
Cracking

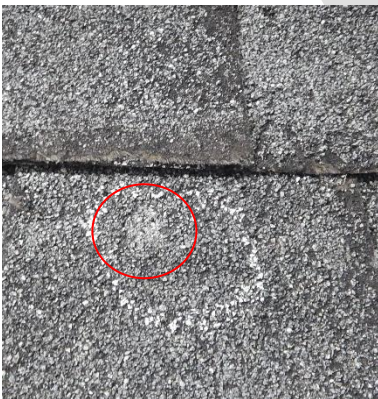
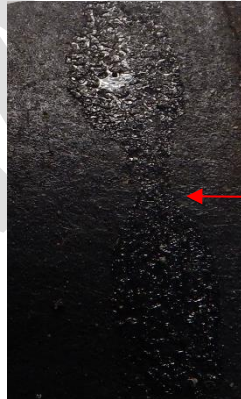
Pass – No  
Cracking

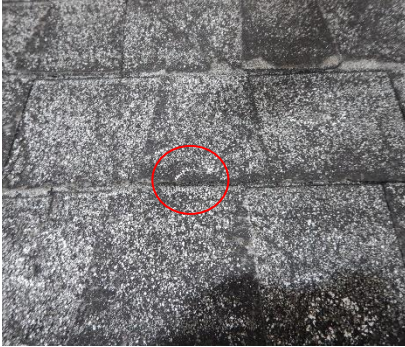
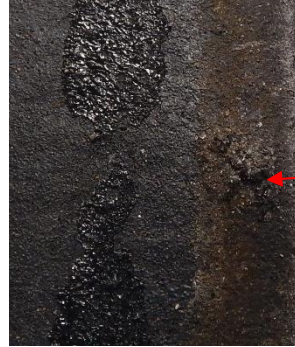
Deck A Hail Test Double Edge

Fail -  
Cracking

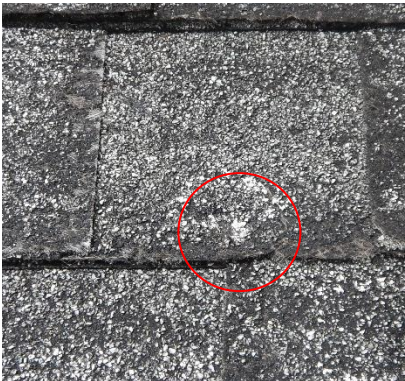
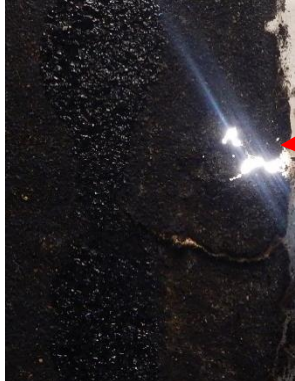
Deck A Hail Test Single Lap

Fail -  
Cracking

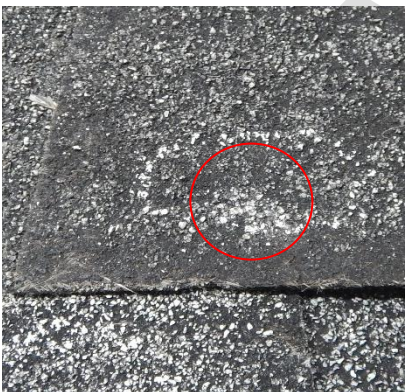
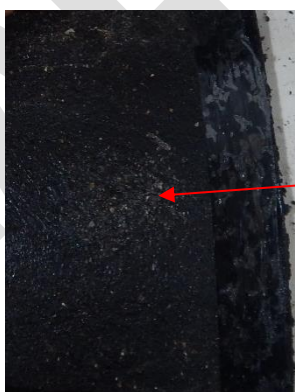
Deck A Hail Test Double Field

Pass – No  
Cracking

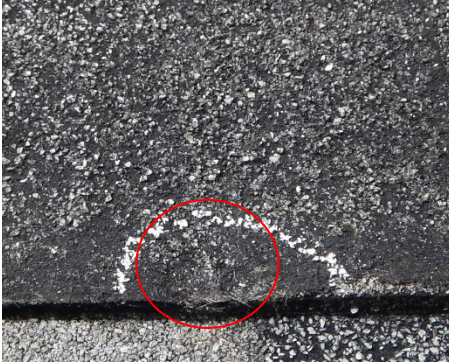
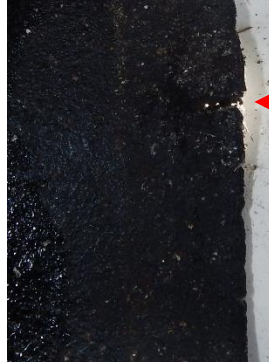
Deck B Hail Test Double Edge

Fail -  
Cracking

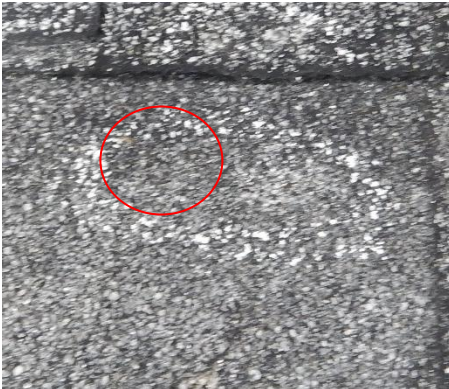
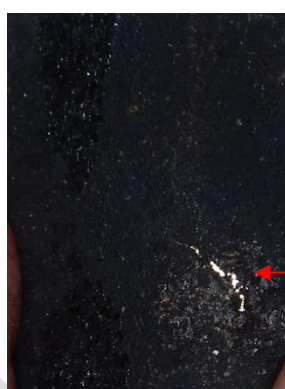
Deck B Hail Test Single Field

Fail -  
Cracking

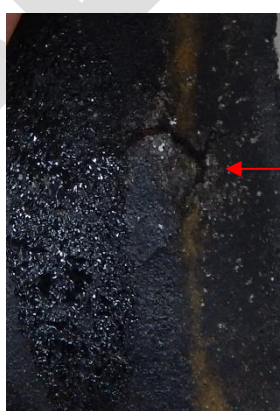
Deck B Hail Test Double Field

Fail -  
Cracking

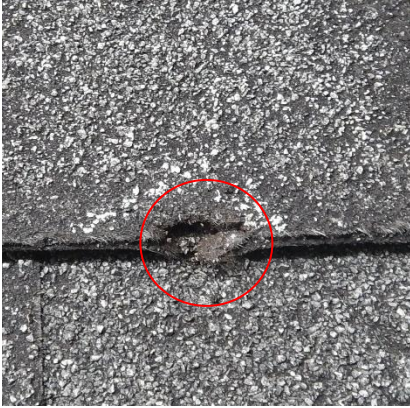
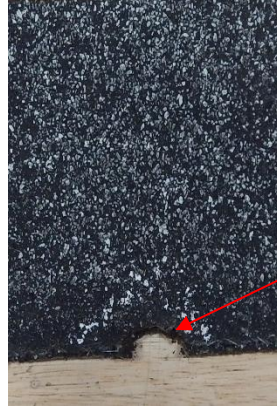
Deck C Hail Test Double Edge

Fail -  
Broke

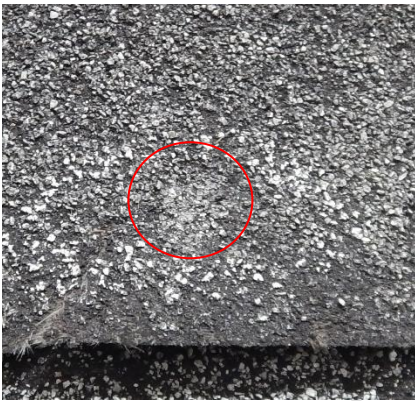
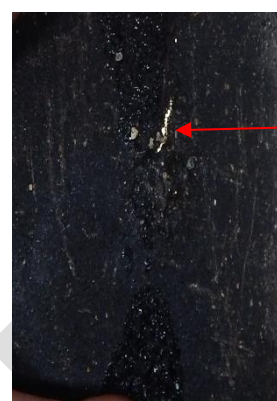
Deck C Hail Test Single Lap

Fail -  
Cracking

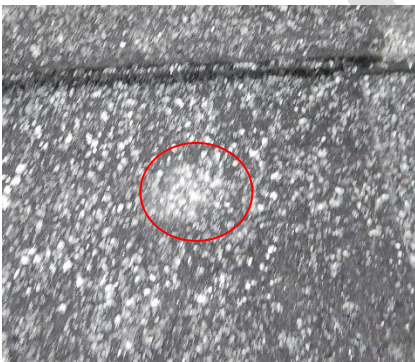
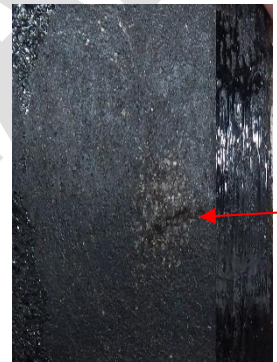
Deck C Hail Test Double Field

Fail -  
Cracking

At the treatment level selected all test specimens exhibited cracking, breakage, and/or dis-bonding when subjected to hail impact testing. No discernable difference was observed with the application of the rejuvenators.

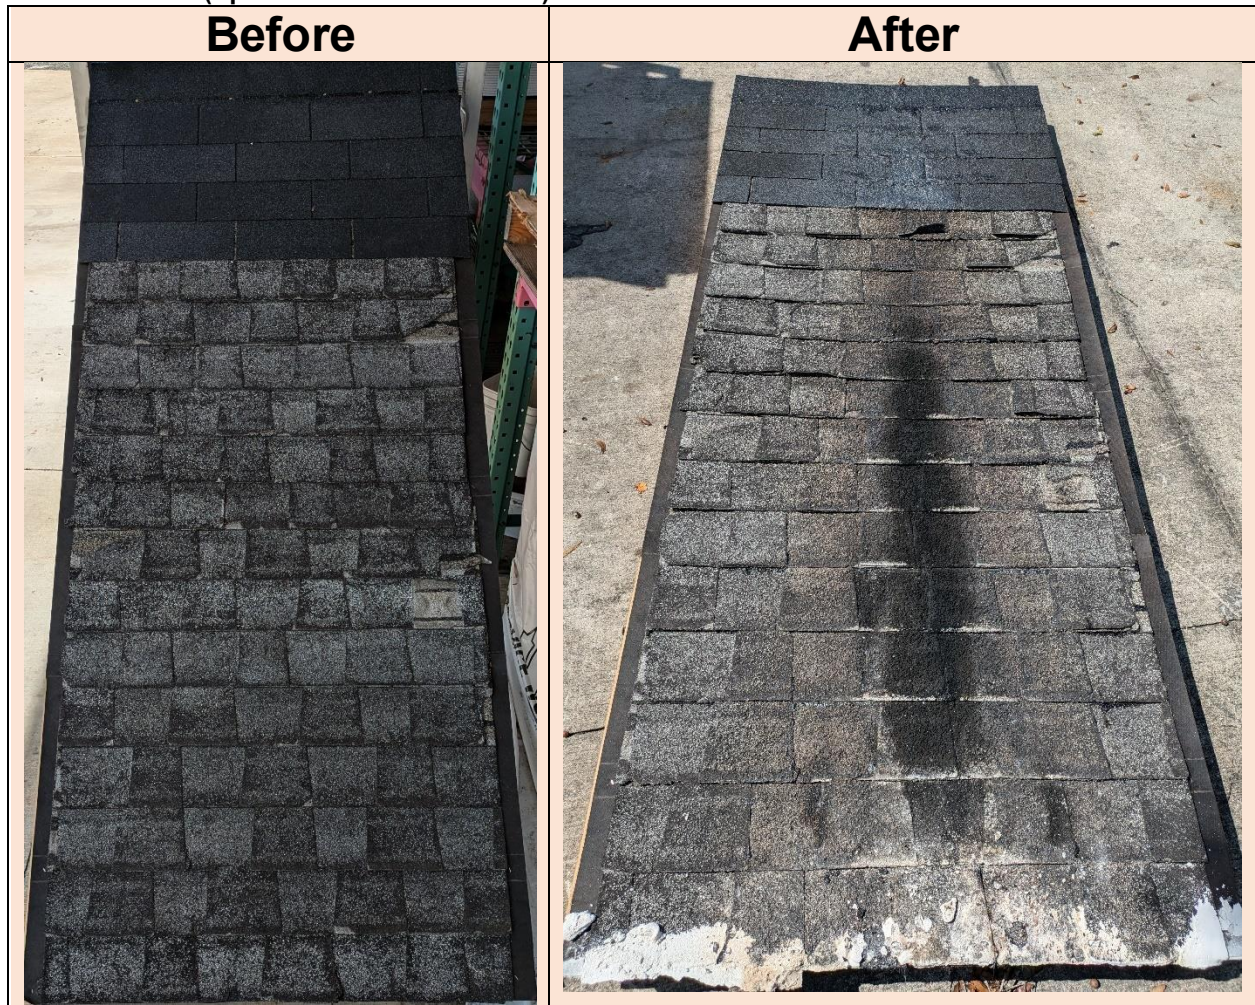
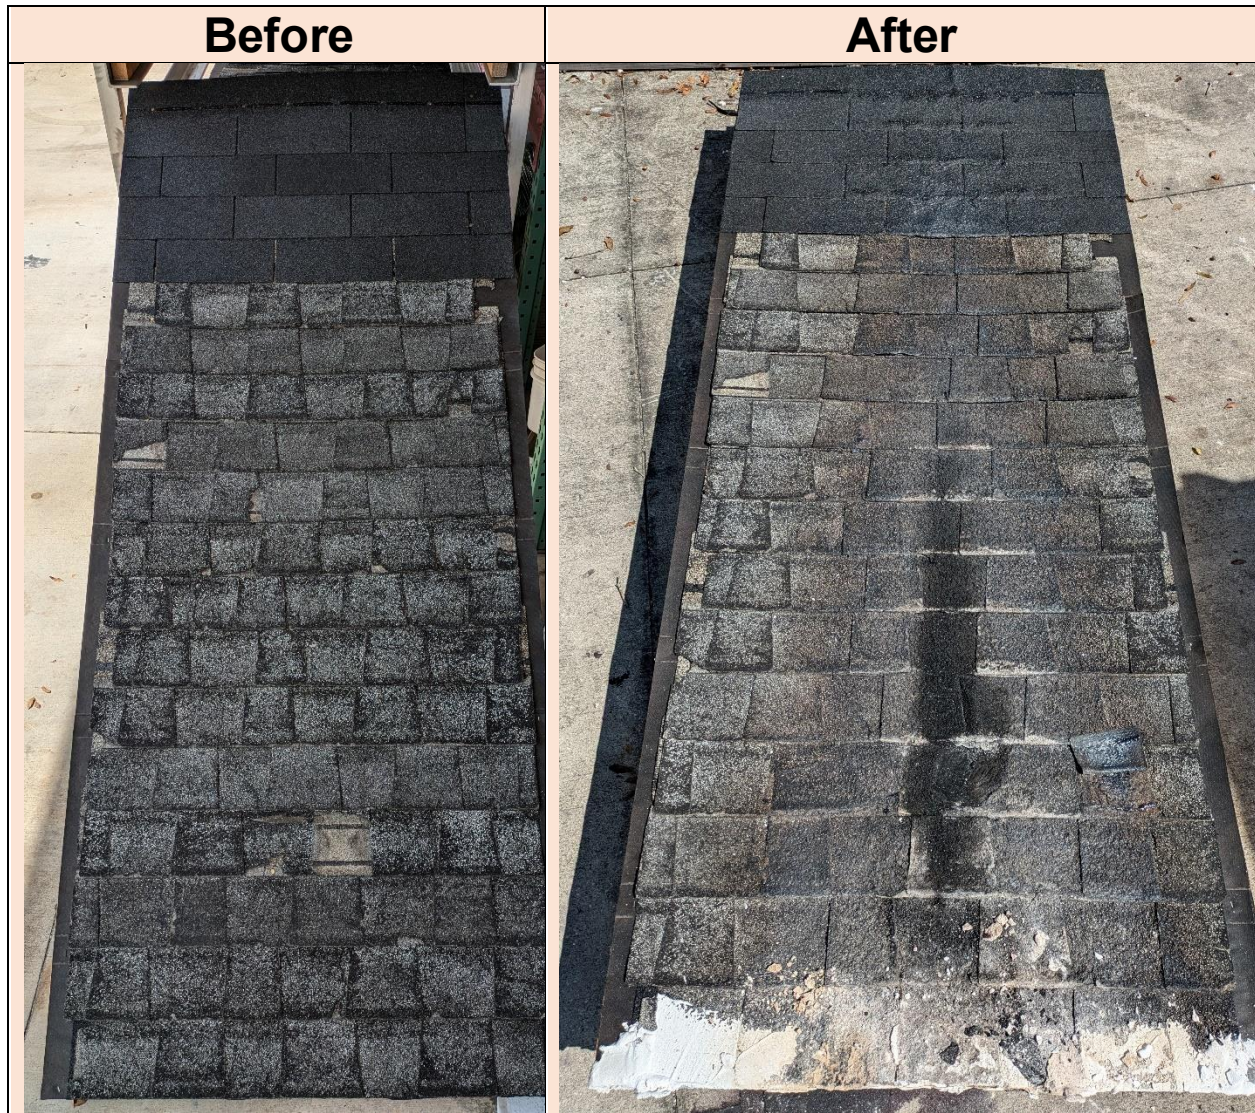
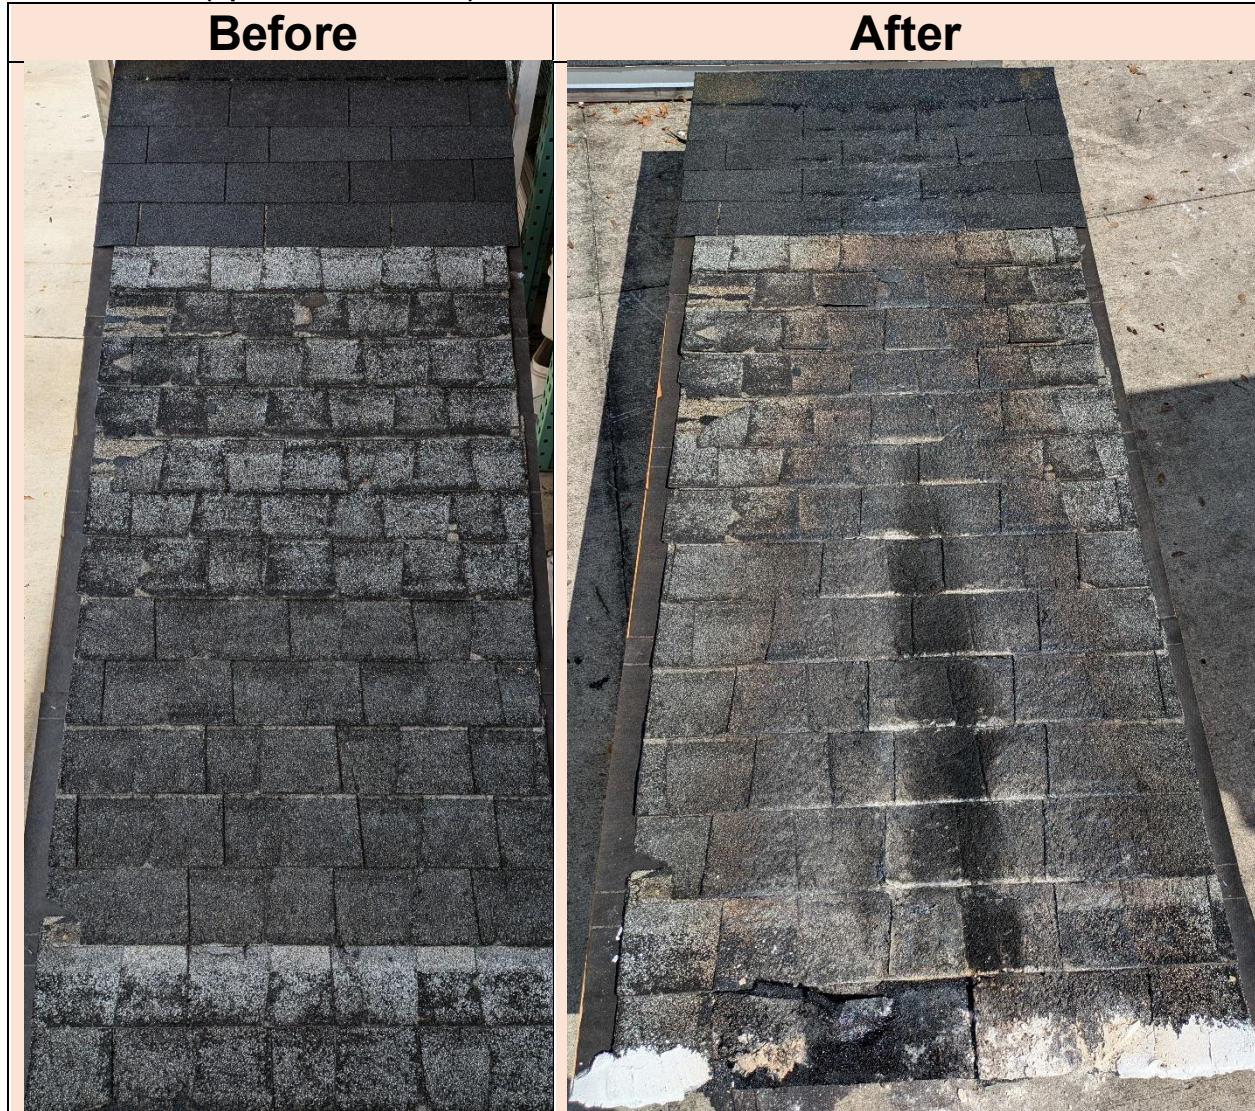
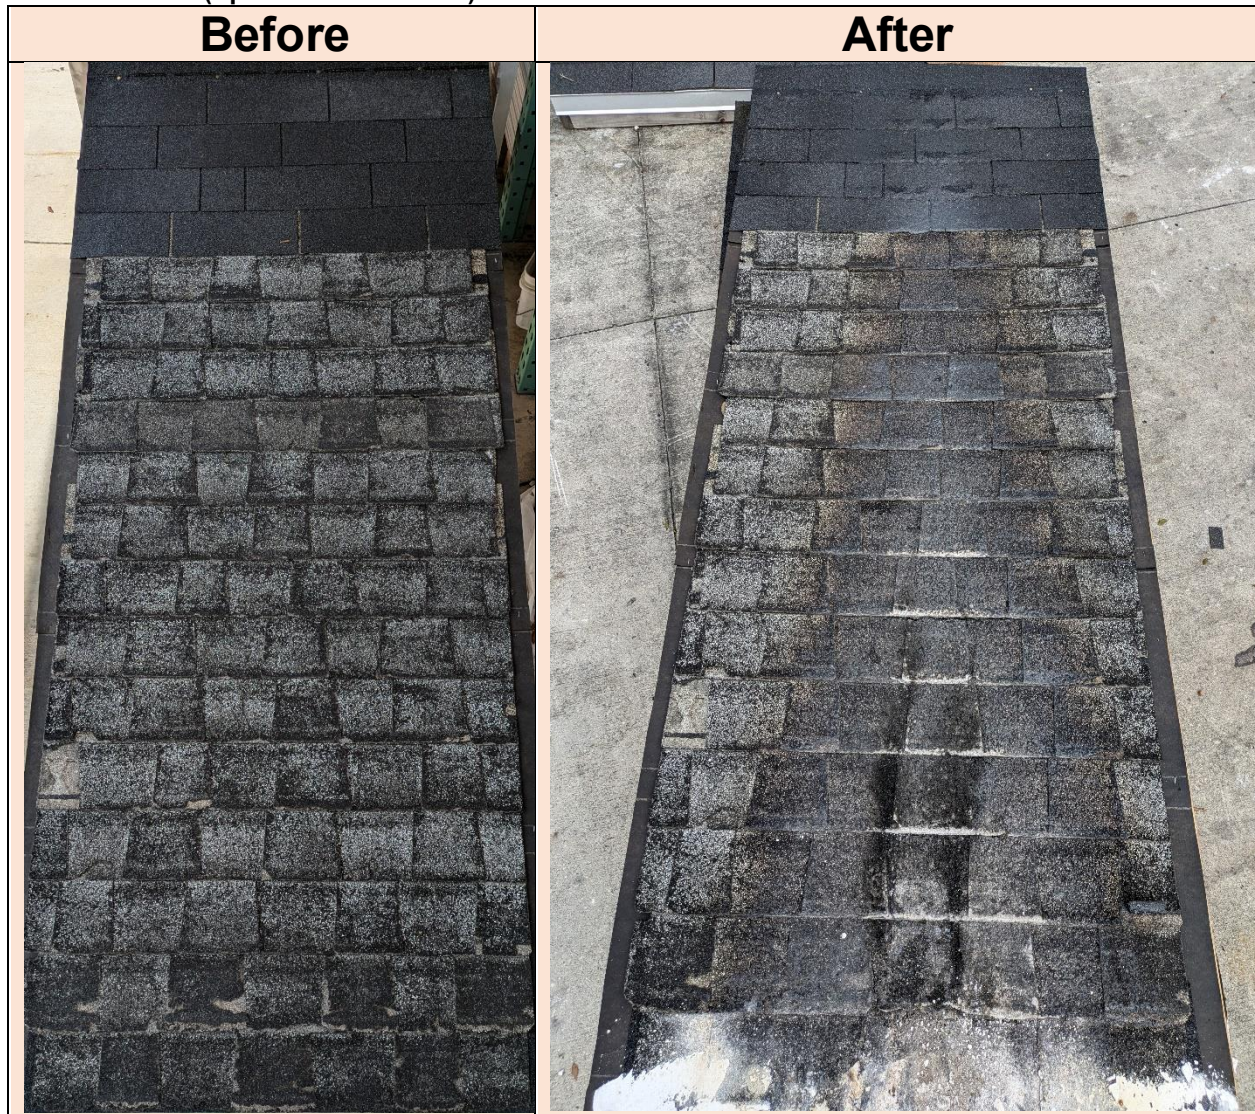
The addition of the rejuvenators to the roof decks slightly reduces the spread of flame. All but the sample treated with Rejuvenator C reduce the time to ignition, but not enough to cause the shingles to fail to meet the Class A requirements.

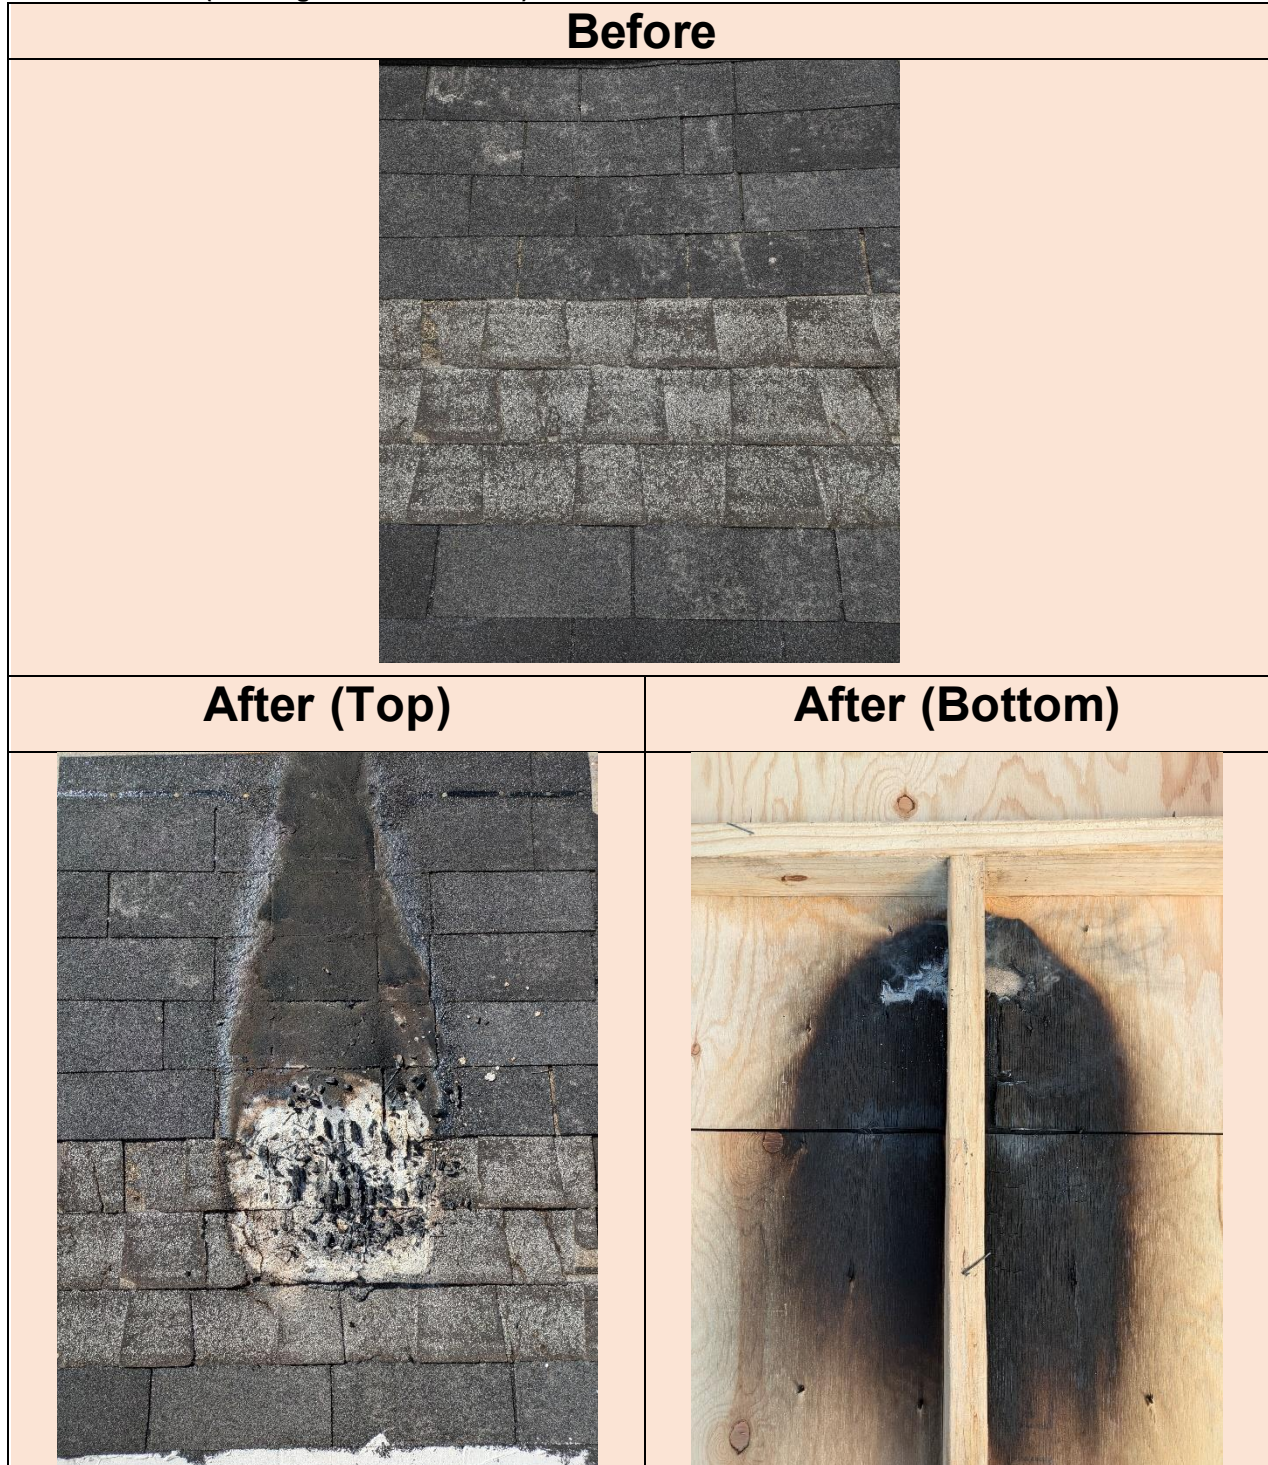
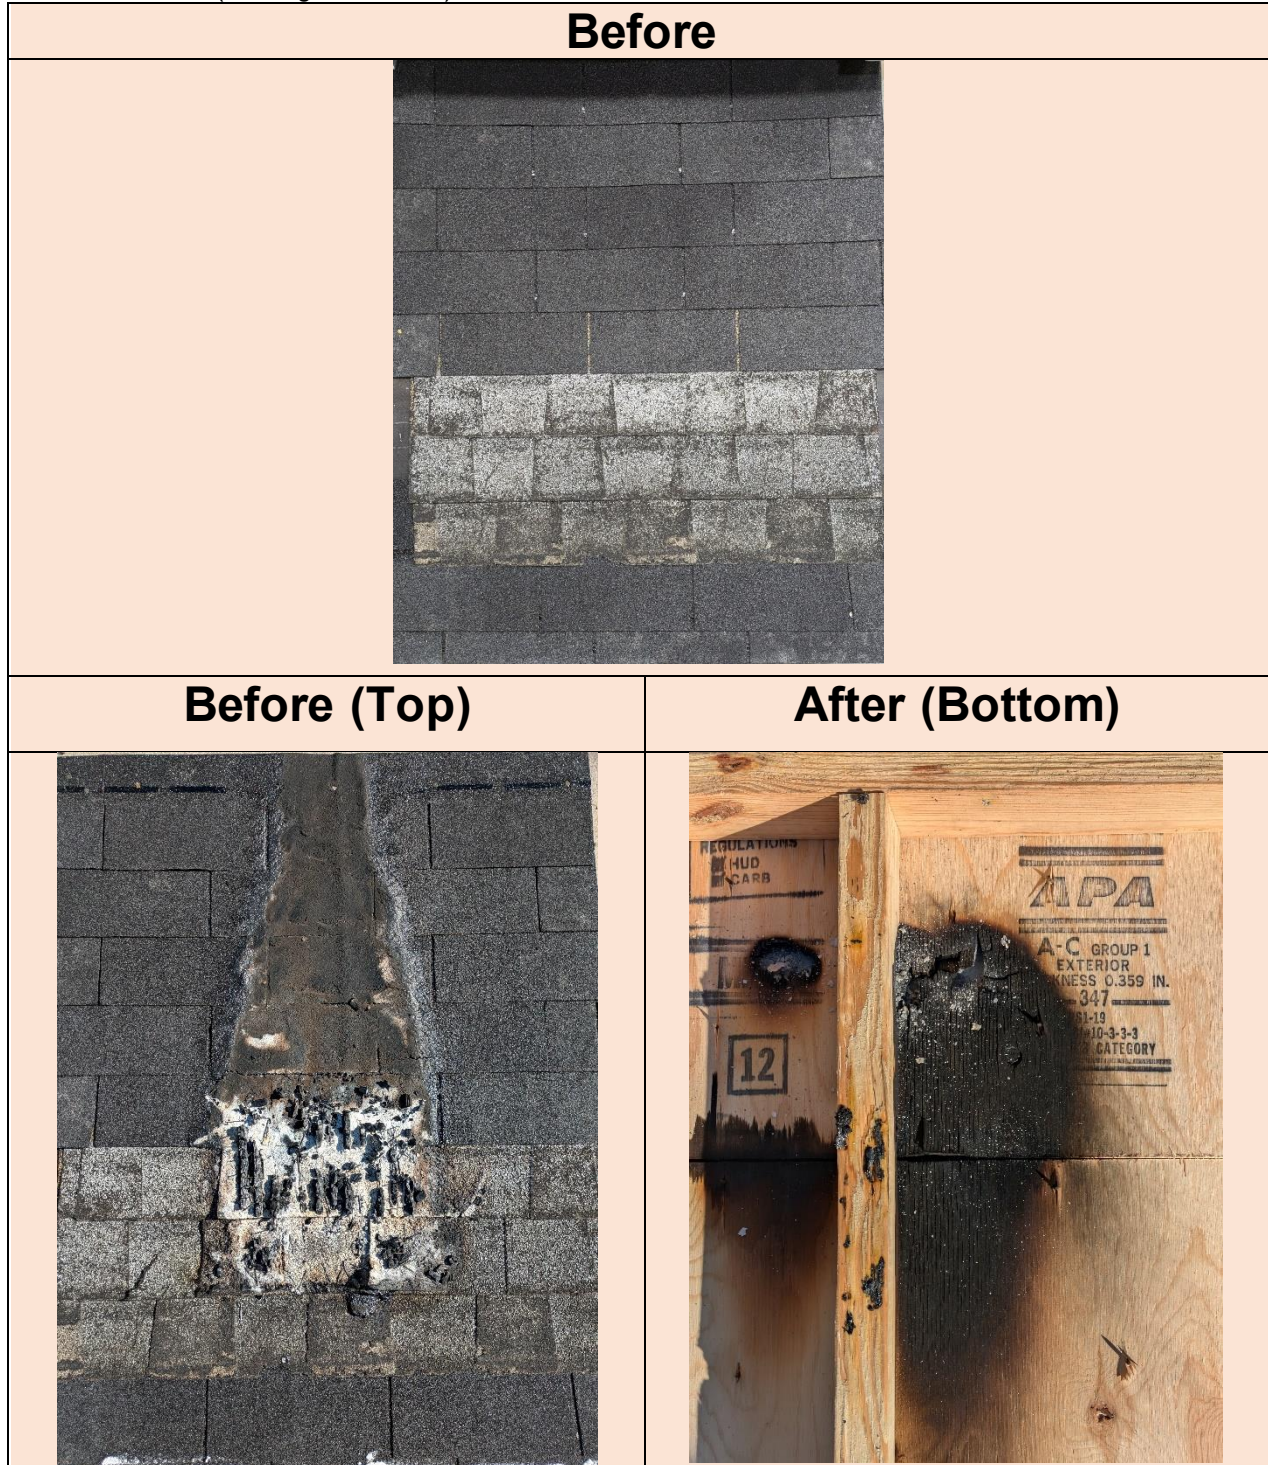
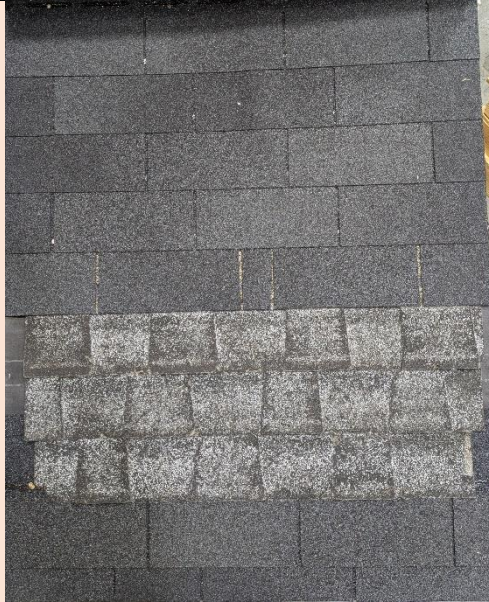
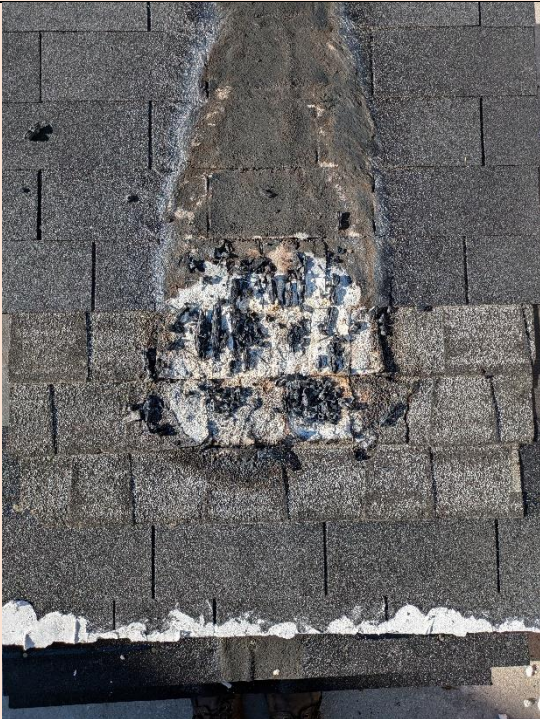
All four of the tested decks failed the Burning Brand test. With all four decks sustained flames were observed on the underside of the roof deck during testing.

The addition of the rejuvenators to the roof decks appears to have a negligible effect on the results of the burning brand test.
